SAMPLE INSPECTION REPORT

Product name	Copper Water bottles		
Product reference	CWB01	PO No.	
Supplier name		Date	10 th August
Supplier Address			
Supplier Email		Supplier phone

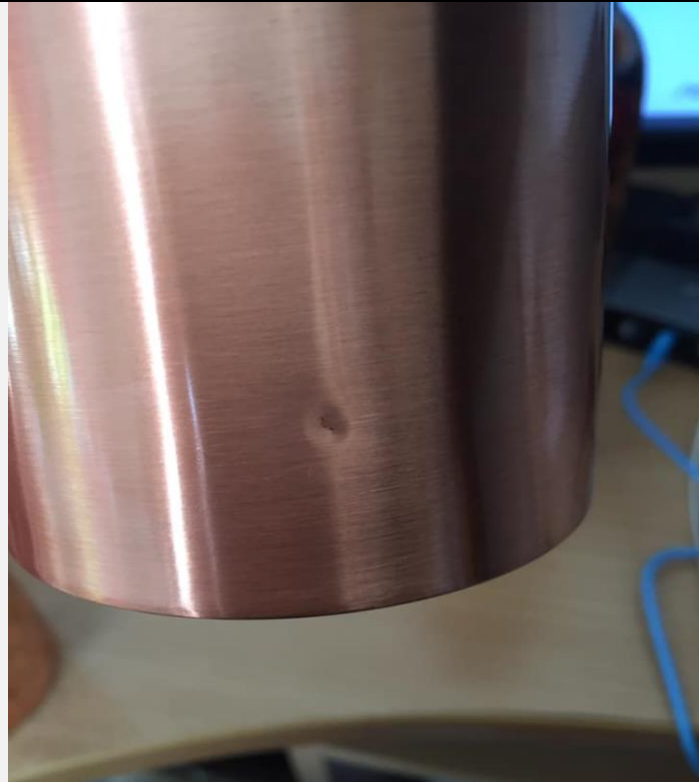
Description of defect	Defect category & No.		
	Critical	Major	Minor
[Description of 1 st defect] One minor dent in brushed bottle			x

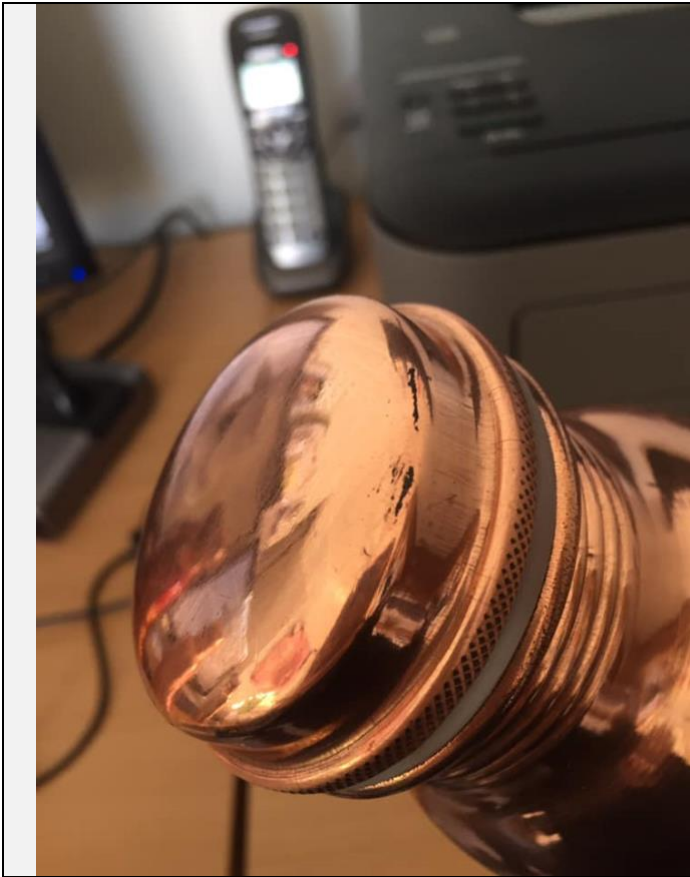
[Description of 2 nd defect] Minor black scuff marks on lid of hammered bottle			x

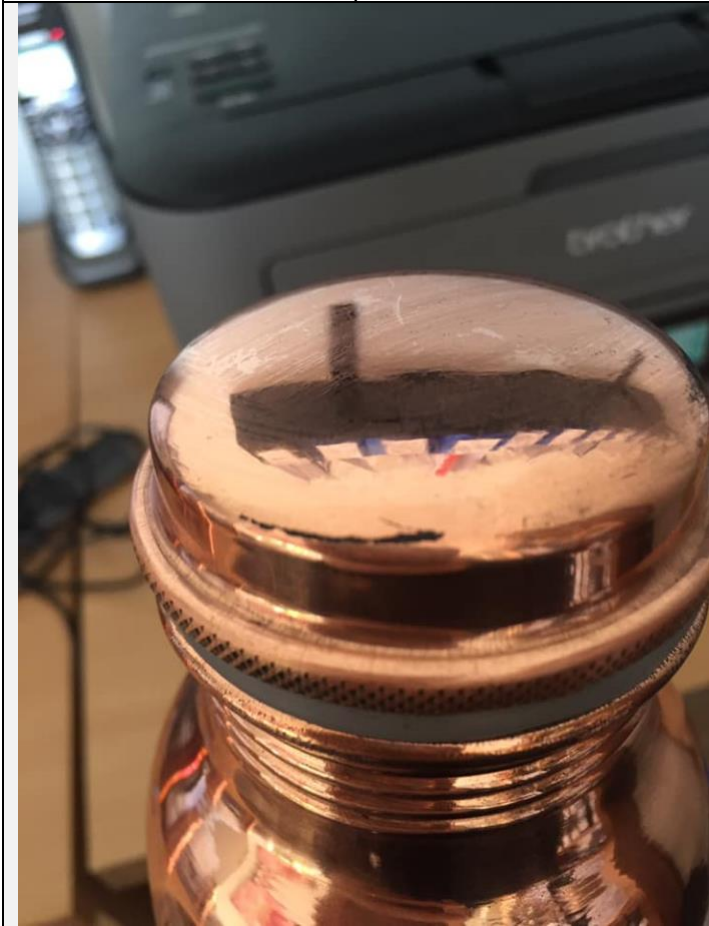
[Description of 3rd defect] Black marks did rub off ok. However, did ruin the first impression of the bottle
